# Manhole Inspection Summary

Manhole # S25AA\_008MH

**Location** Address: **905 FREMONT AVE**

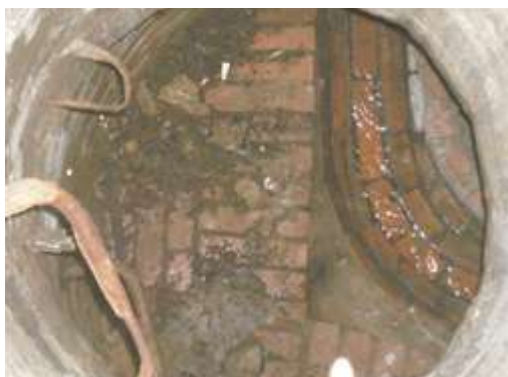
Top View

Comments **RETOOK TOP VIEW PHOTO. TOP VIEW DOES NOT SHOW CONNECTIVITY DUE TO CHANNEL OFFSET CONDITION. 4-17-09**

TOP VIEW DOES NOT SHOW  
CONNECTIVITY DUE TO CHANNEL  
OFFSET CONDITION

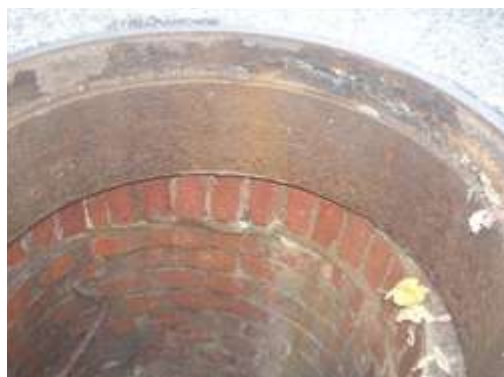
Defect 3

Condition: ☐ Sound ☐ Cracked ☐ Root Intrusion ☒ **Loose Brick** ☐ Deteriorated

CHIMNEY BRICKS ARE A LITTLE  
LOOSE

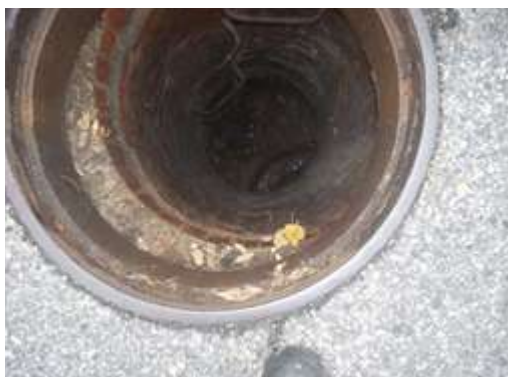
Defect 2

Count: **3** Missing: **3** ☒ **Corroded**

MISSING AND CORRODED STEPS

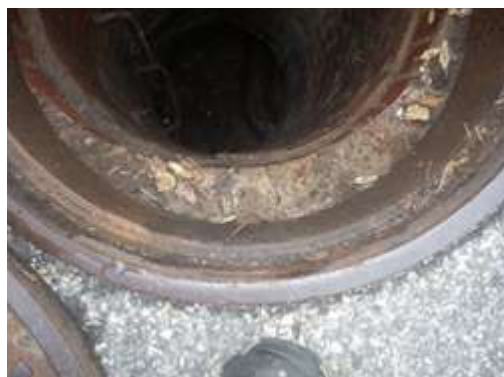
Defect 1

Offset: **4** (in.)

FRAME OFFSET

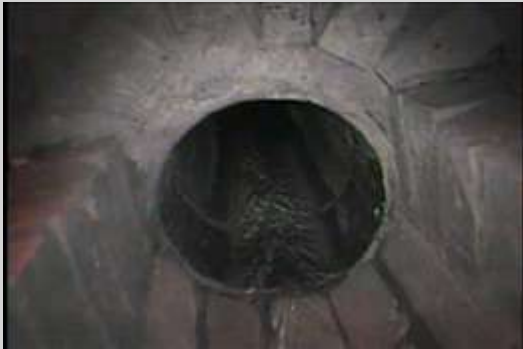
12 O'Clock Outflow

Pipe Height: **7.2** (in.) Rod and Bar (Angled)  
Pipe Material: **Clay** ☐ Pipe Lined  
Invert Depth: **11.11** (ft.) Flow Characteristics: **Slow**  
Deposits: ☒ None ☐ Mud ☐ Sludge ☐ Debris ☐ Grease  
Silt Depth: (in.) Deposits Extent:  
Infiltration: **None** Pipe Seal Cond: **Sound**

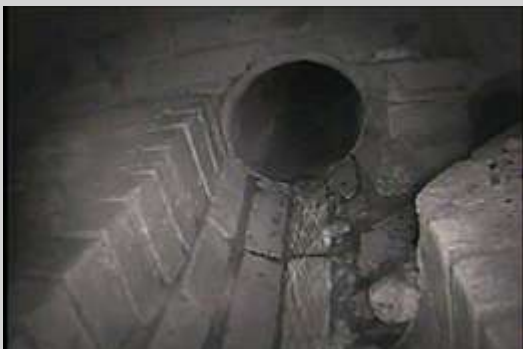
3 O'Clock Inflow

Pipe Height: **8.4** (in.) Rod and Bar (Angled)  
Pipe Material: **Clay** ☐ Pipe Lined  
Invert Depth: **11.03** (ft.) Flow Characteristics: **Slow**  
Deposits: ☒ None ☐ Mud ☐ Sludge ☐ Debris ☐ Grease  
Silt Depth: (in.) Deposits Extent:  
Infiltration: **None** Pipe Seal Cond: **Sound**

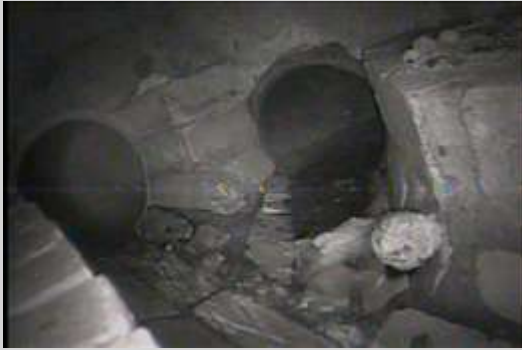
4 O'Clock Inflow

FRAME OFFSET

Infiltration: **None** Pipe Seal Cond: **Sound**
